Case 279 : Narrative

Case Vehicle (A): 2001 Ford	Veh. (B): 1993 Pontiac
Type: Explorer Sport, 4 x 2, 2-door SUV	Type: Bonneville SE, 4-door sedan
Driver: 38-year-old female	Driver: 34-year-old male
CDC: 12-FDEW-2	CDC: 04-RZAW-4

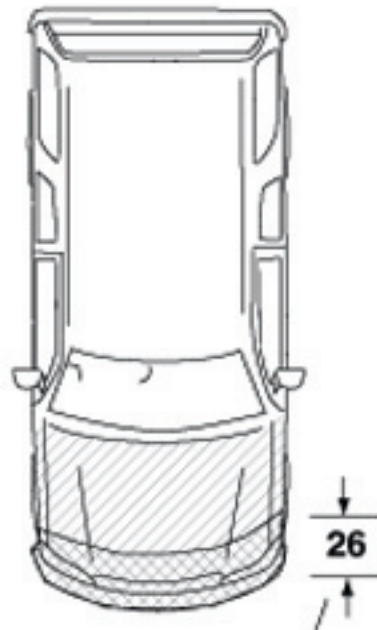
Max. crush to left
front bumper corner

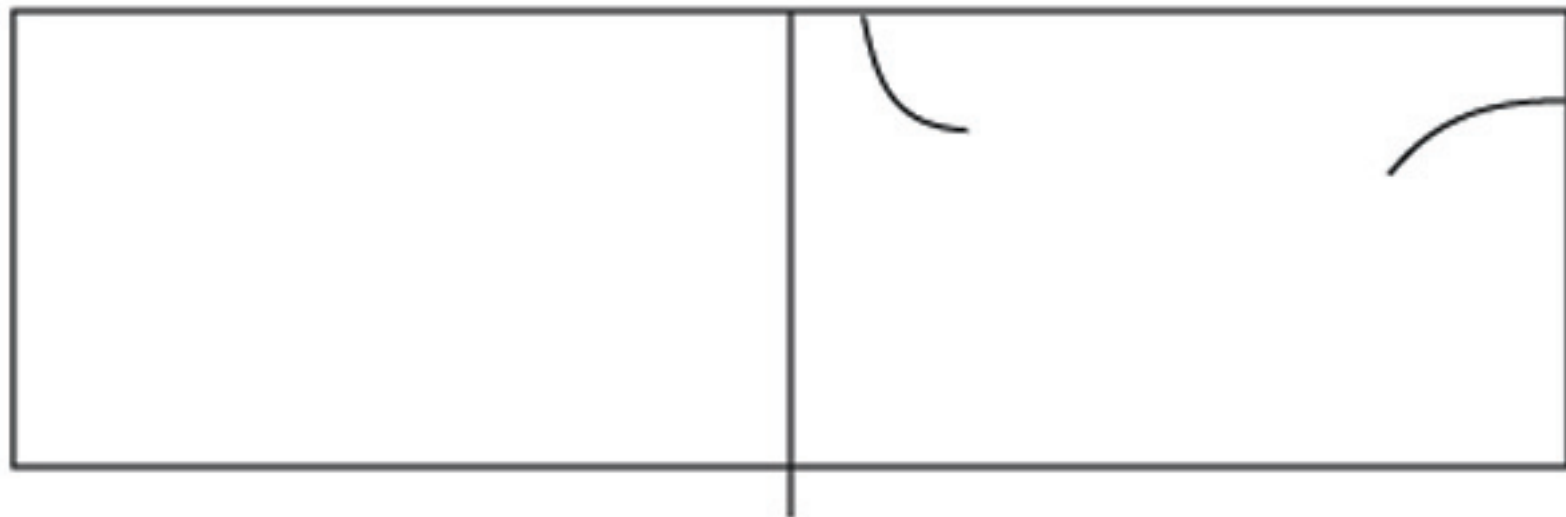
WINDSHIELD MARK ON CASE VEHICLE:

Cracked due to body distortion or impact forces

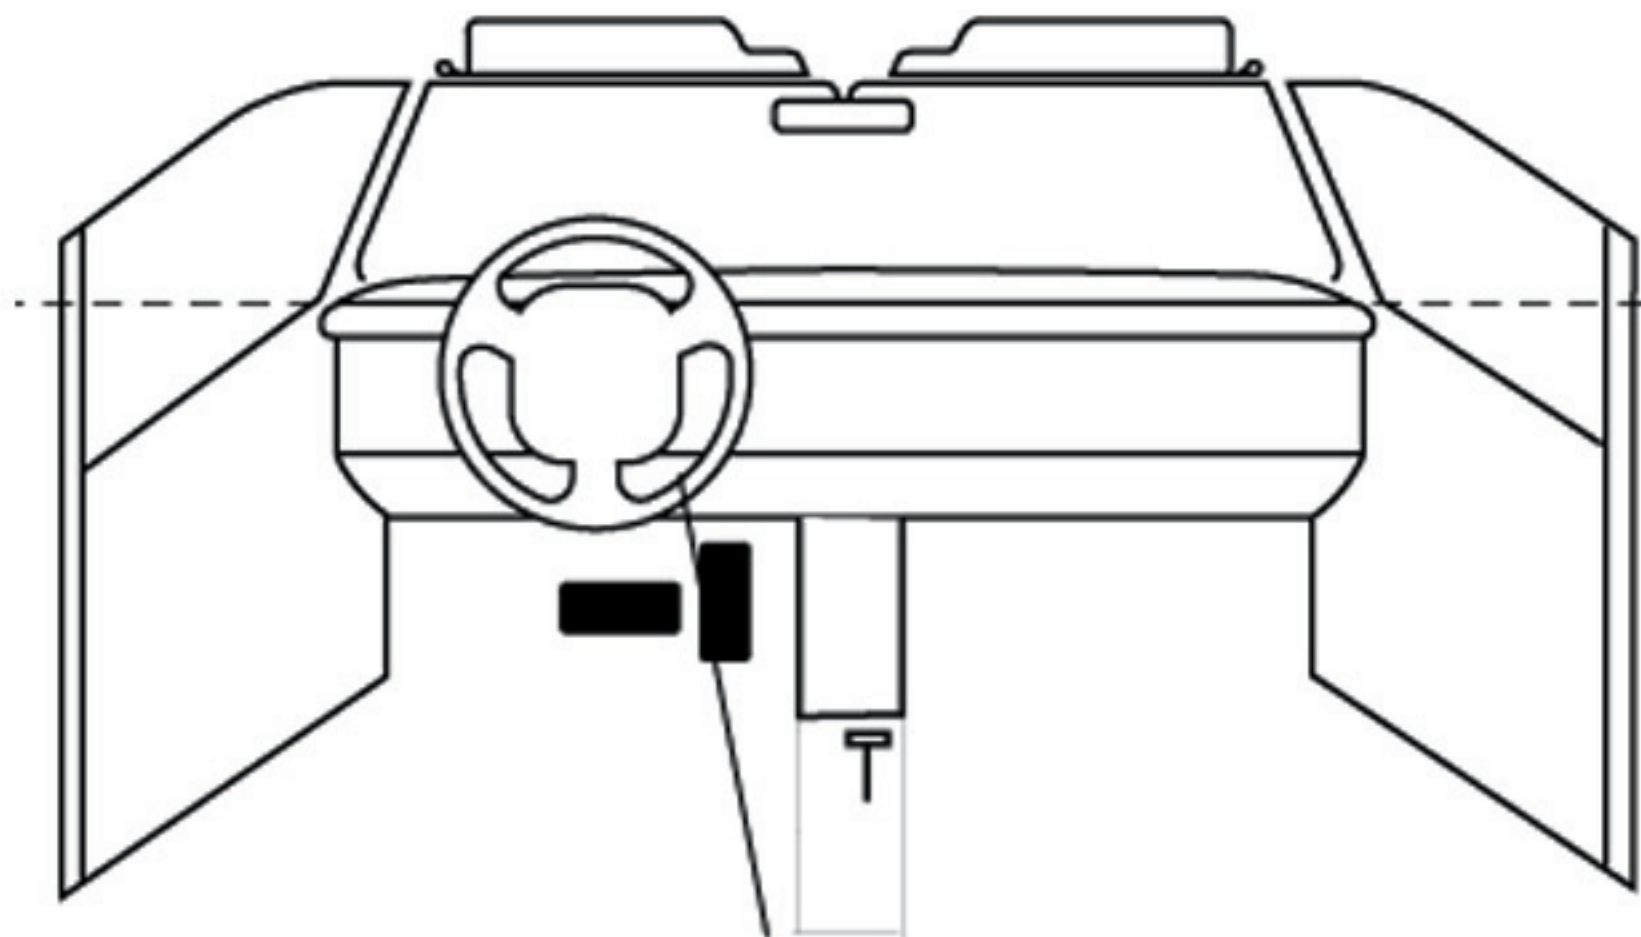
the anterior aspect of the right leg below the knee, probably due to contact with the knee bolster, [50](#) as evidenced by the scuff mark on the plastic knee bolster cover.

A = knee bolster,
scuff mark

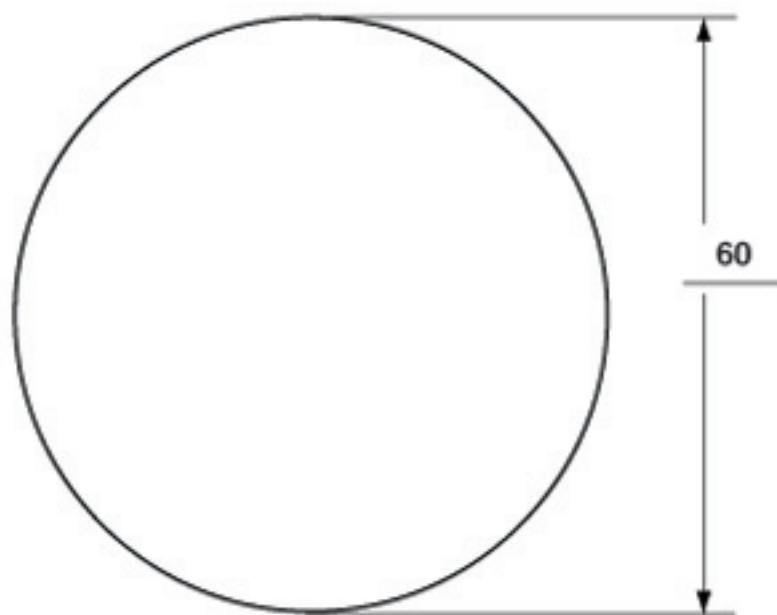
Driver Airbag

Vents: ☒ Y ☐ N
if yes, how many: 2
at 1 and 11 o'clock

Tethers: ☒ Y ☐ N
if yes, how many: 2

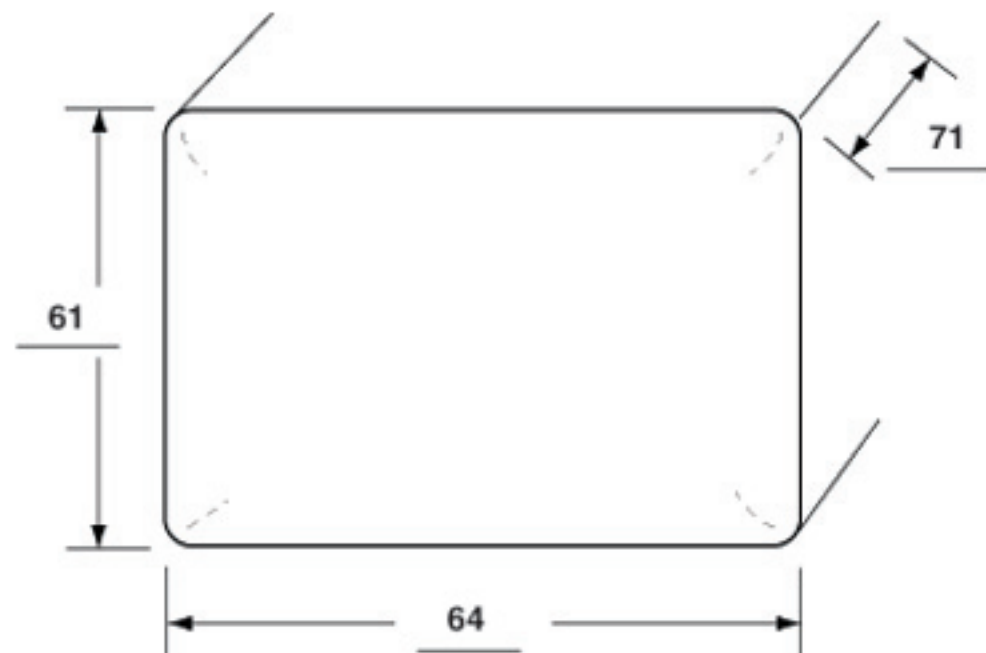
Passenger Airbag

Vents: ☒ Y ☐ N
if yes, how many: 2

@ 3 and 9 o'clock
